Preliminary Science Flight Report

Operation IceBridge Antarctica 2011

Flight: GV-FL06
Mission: LVIS-Evans2

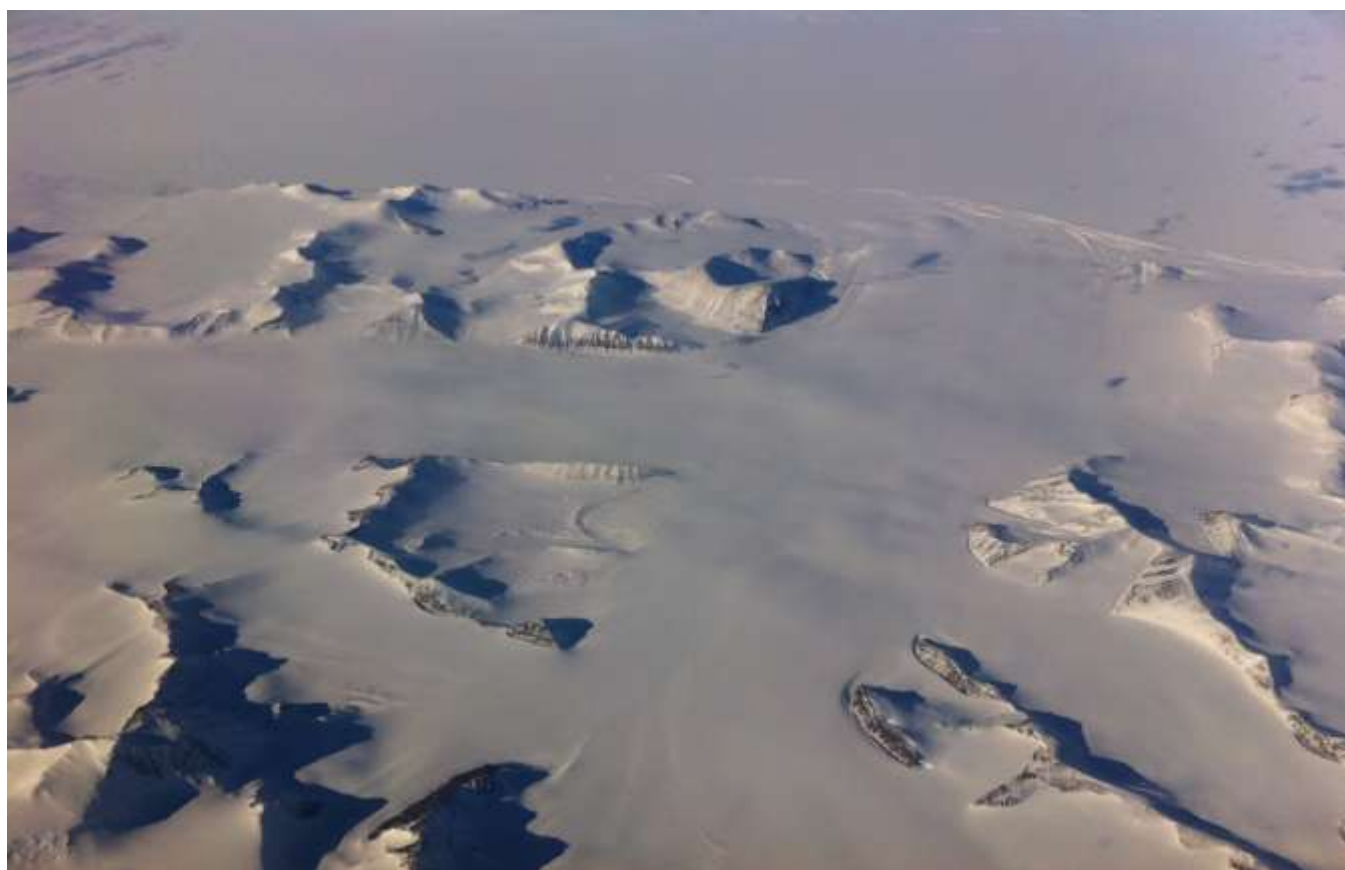
Flight trajectory for today's flight is in gold.

The fifth LVIS G-V flight surveyed a series of lines centered at the Evans Ice Stream plus transit lines to and from the survey area. Five, ~350km long grid lines, spaced ~20km apart and extending the Evans-1 survey grid from 10/12/11 were completed. All planned lines were surveyed, a total of ~3,000 lineal km, ~6,000 km² mapped. The survey is part of the overall deployment plan to collect grid data over a large region that encompasses the entire Antarctic Peninsula to the Getz Coast.
